# IONOSPHERIC EXPOSURE FACILITY SPACELABORATORIES HANDBOOK

Science Applications International Corporation

October 1993

Final Report

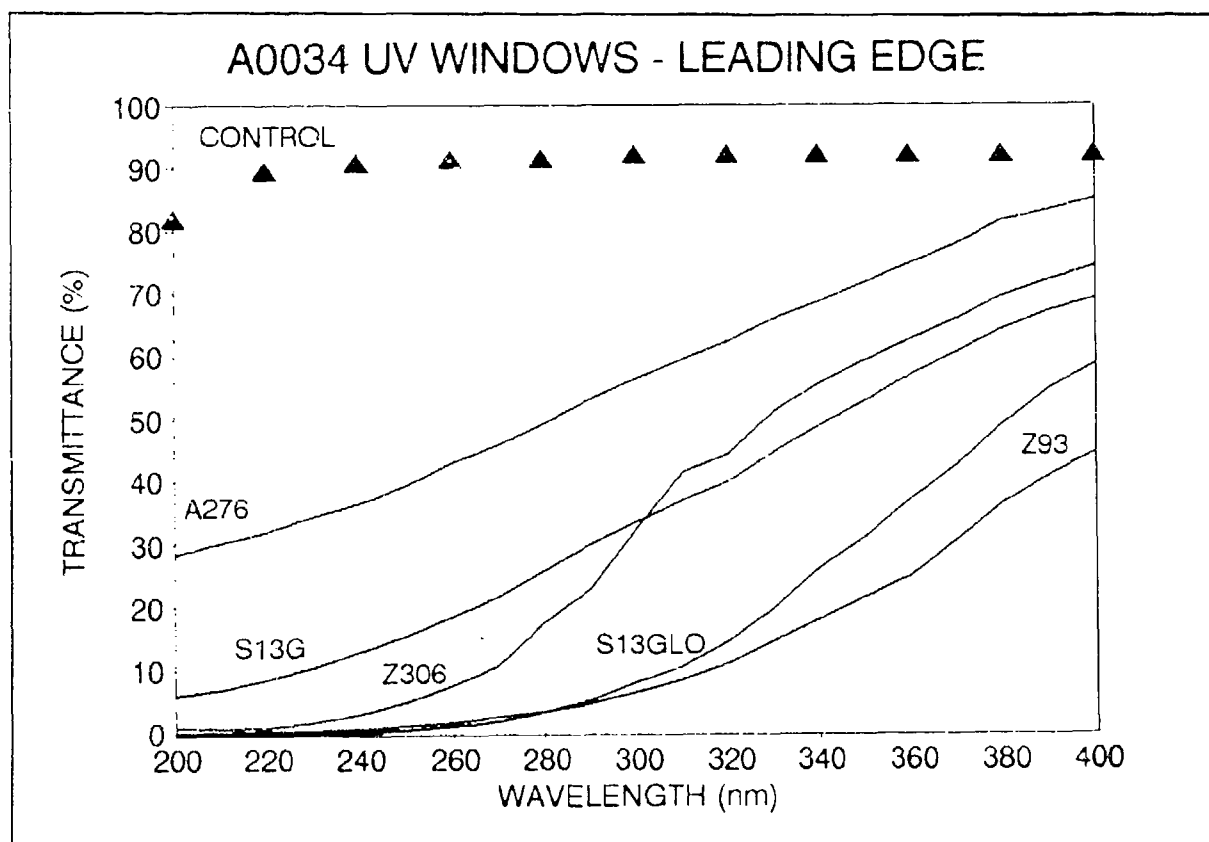
**Figure E.114. Thermal Control Generated Transmission Loss: UV Window**

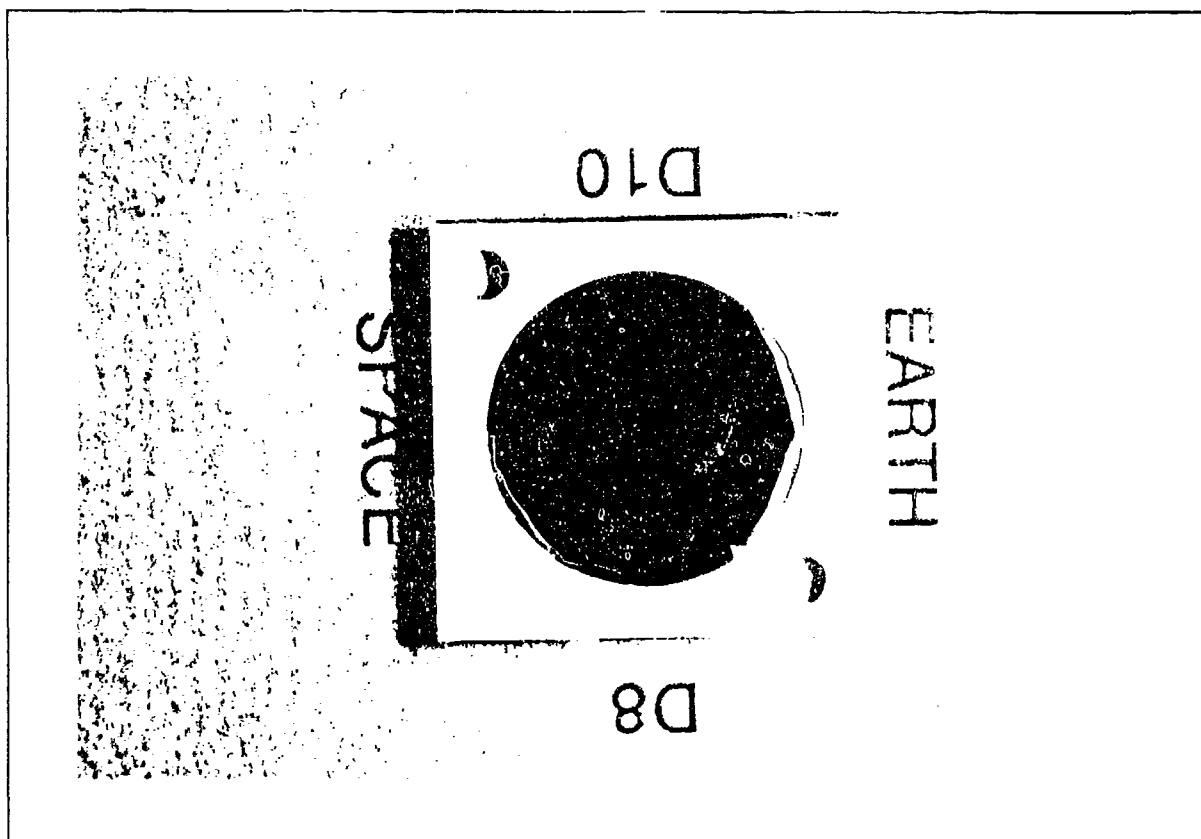
Figure E.115. Hazed and Contaminated Reflective 350 nm Coating on 7940 Fused Silica
